# Manhole Inspection Summary

## Manhole # S17C1\_011MH

Insp Date: **5/15/08 9:17 AM**

**Location** Address: **2821 carroll st**

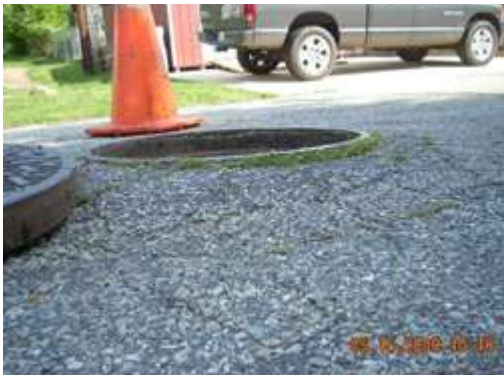
Defect 3

frame above grade

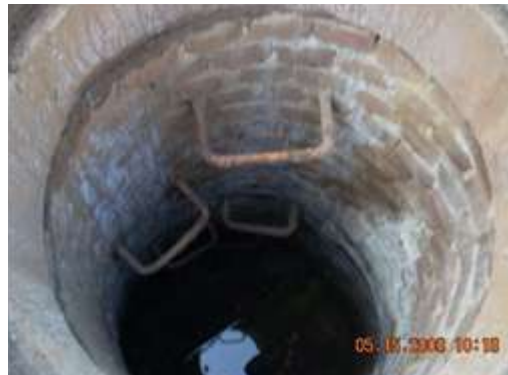
Defect 2

**Steps** Count: **5** Missing: **0** ☒ **Corroded**

corroded steps

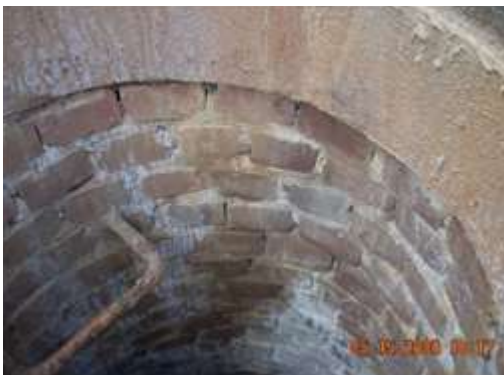
Defect 1

Condition: ☐ Sound ☐ Cracked ☐ Root Intrusion ☒ **Loose Brick** ☐ Deteriorated

Infiltration: ☐ None ☒ **Joint** ☐ Cracks ☐ Mortar ☐ Roots ☐ Wall

corbel loose bricks, infiltration @  
corbel/frame joint

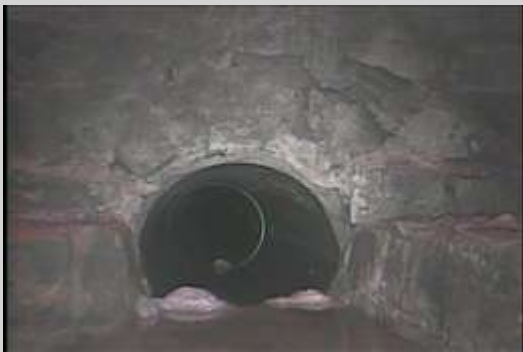
12 O'Clock Outflow

Pipe Height: **8.4** (in.) Rod and Bar (Angled)  
Pipe Material: **Clay** ☐ Pipe Lined  
Invert Depth: **9.23** (ft.) Flow Characteristics: **Slow**  
Deposits: ☐ None ☐ Mud ☒ Sludge ☒ Debris ☐ Grease  
Silt Depth: **2** (in.) Deposits Extent: **Light**  
Infiltration: **None** Pipe Seal Cond: **Sound**

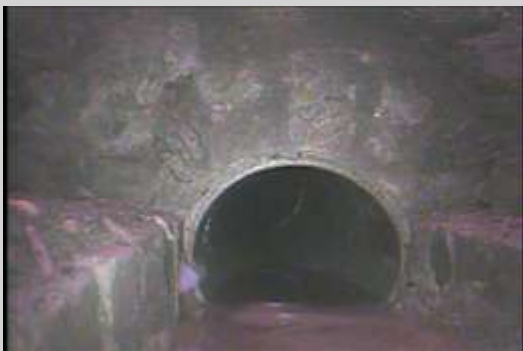
6 O'Clock Inflow

Pipe Height: **8.4** (in.) Rod and Bar (Angled)  
Pipe Material: **Clay** ☐ Pipe Lined  
Invert Depth: **9.20** (ft.) Flow Characteristics: **Slow**  
Deposits: ☒ None ☐ Mud ☐ Sludge ☐ Debris ☐ Grease  
Silt Depth: **0** (in.) Deposits Extent:  
Infiltration: **None** Pipe Seal Cond: **Sound**

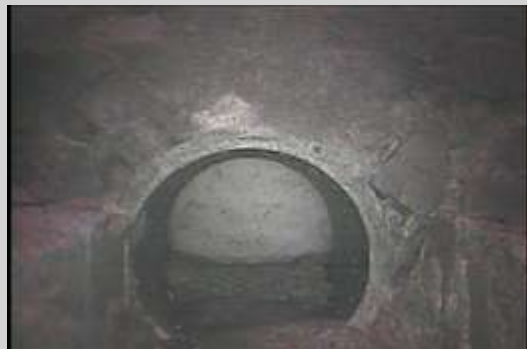
9 O'Clock Inflow

Connects To: **Stub connection / abandoned**
